# ANALYSIS OF GENIECLIP® MOUNT

The efficacy of **Pliteq GenieClip Mount** to reduce structure-borne noise and vibration from kitchen cabinet door slams while maintaining high sound transmission loss

By: Matthew V. Golden, MS Acs, INCE Bd. Cert  
Director, Research and Development, Pliteq Inc.

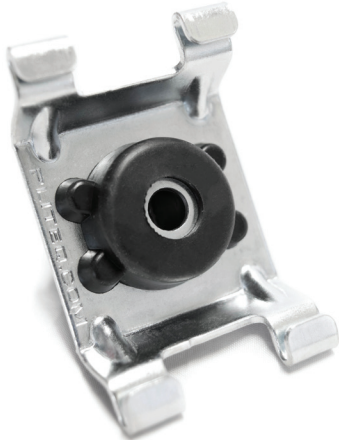
**Figure 1: Pliteq GenieClip RST**

The Pliteq **GenieClip® RST** (**Fig. 1**) was first brought to market in 2008. It was designed with a unique and patented unibody design to connect to a stud or joist and resiliently support a 25 gauge piece of drywall furring channel (**Fig. 2**).

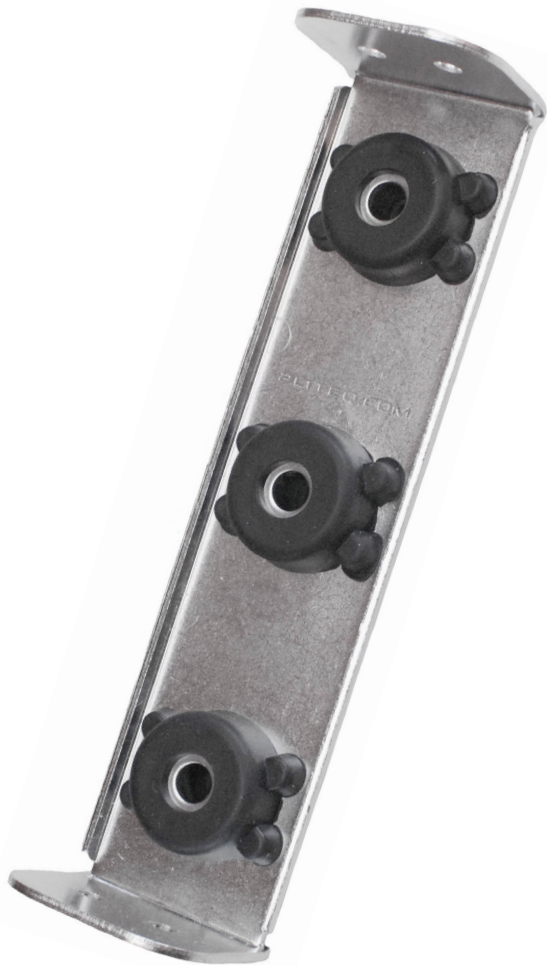
**Figure 3: Pliteq GenieClip Mount**

After these requirements were set, a suitable mounting element was selected. Pliteq’s team of engineers settled on a 20 gauge 6” metal stud track. (Specification for this track can be found in the **GenieClip Mount** installation instructions.) The rest of the design quickly followed. The resulting **GenieClip Mount** design (**Fig. 3**) and installation (**Fig. 4**) met all of the design requirements.

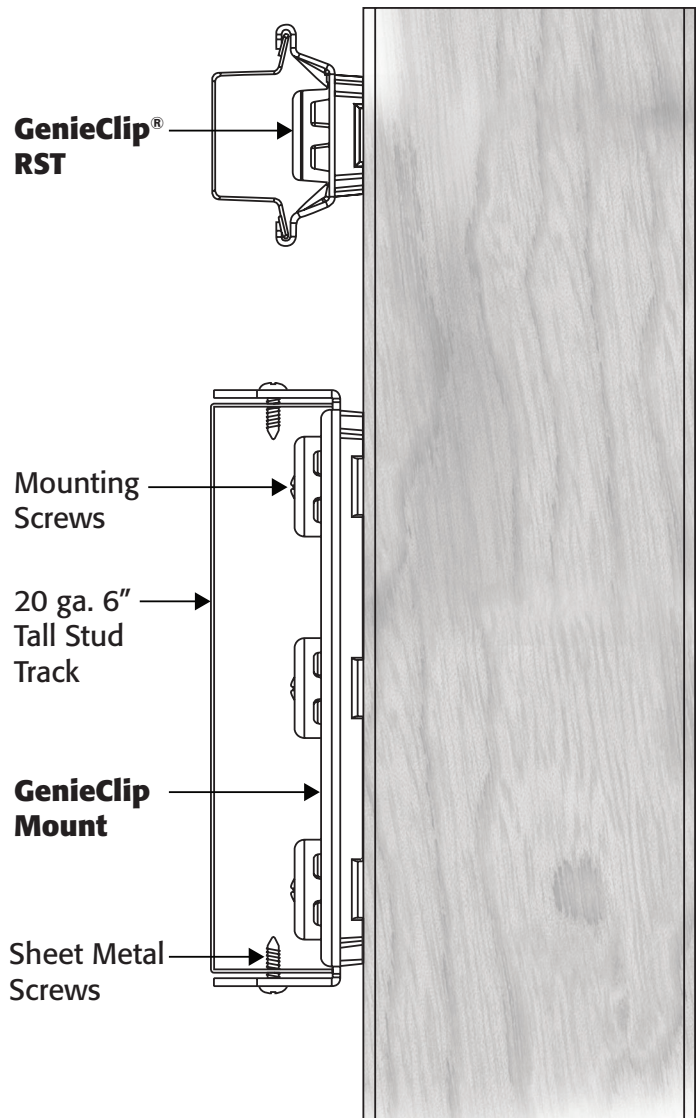
**Figure 4: Side view of GenieClip Mount installed on a wood stud**

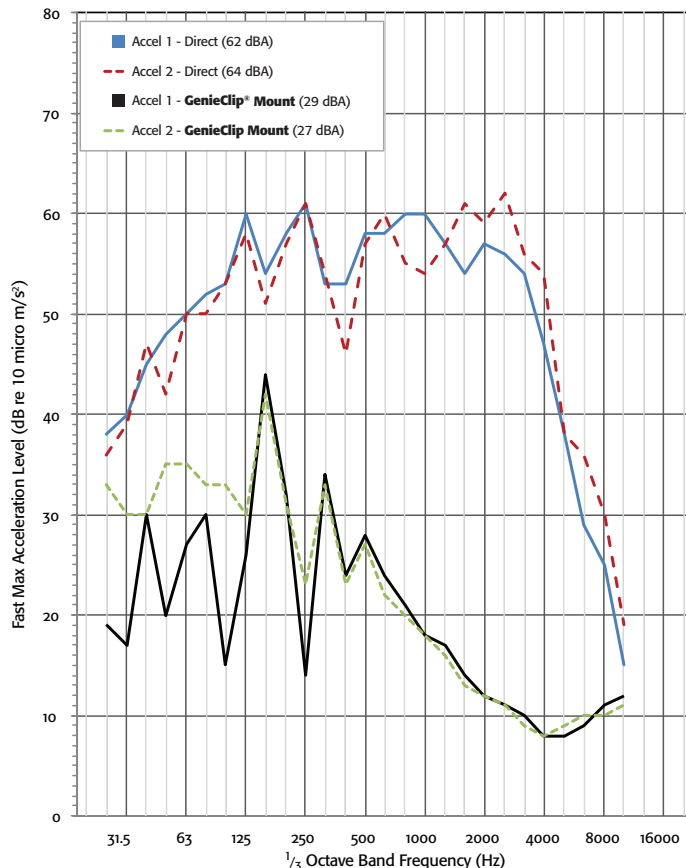
The fast max vibration level on the receiver room side of the wall due to the kitchen cabinet door slams for Assembly 2 and Assembly 5 was compared to assess the effect of the installation of the kitchen cabinet by the **GenieClip Mounts** (Fig. 11). It can be seen

that the installation of the kitchen cabinet on the **GenieClip Mounts** had a very significant effect; over 40 dB at some frequencies. *Note: Accel 1 mounted on the drywall at the location of a stud. Accel 2 mounted on the drywall between the studs.*

**Figure 11: Vibration level on receiver room side of wall due to kitchen cabinet door slams with and without GenieClip Mounts**
